*Threatened and Endangered Species  
Habitat Suitability Assessment Report*

World Olivet Assembly Site  
145 Dover Furnace Road  
Town of Dover, New York

April 18, 2017

Michael Nowicki  
Ecological Solutions, LLC  
1248 Southford Road  
Southbury, CT 06488  
(203) 910-4716

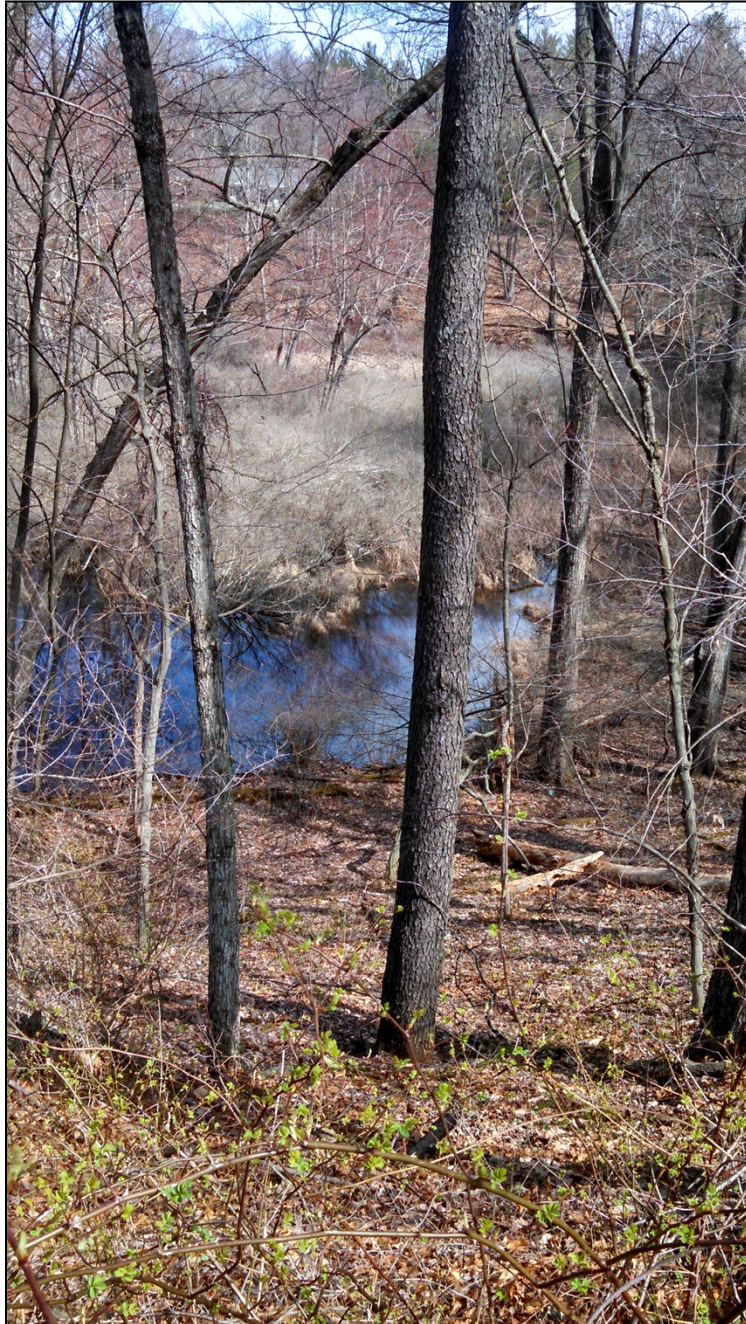
Delineated wetland pocket at center of site.

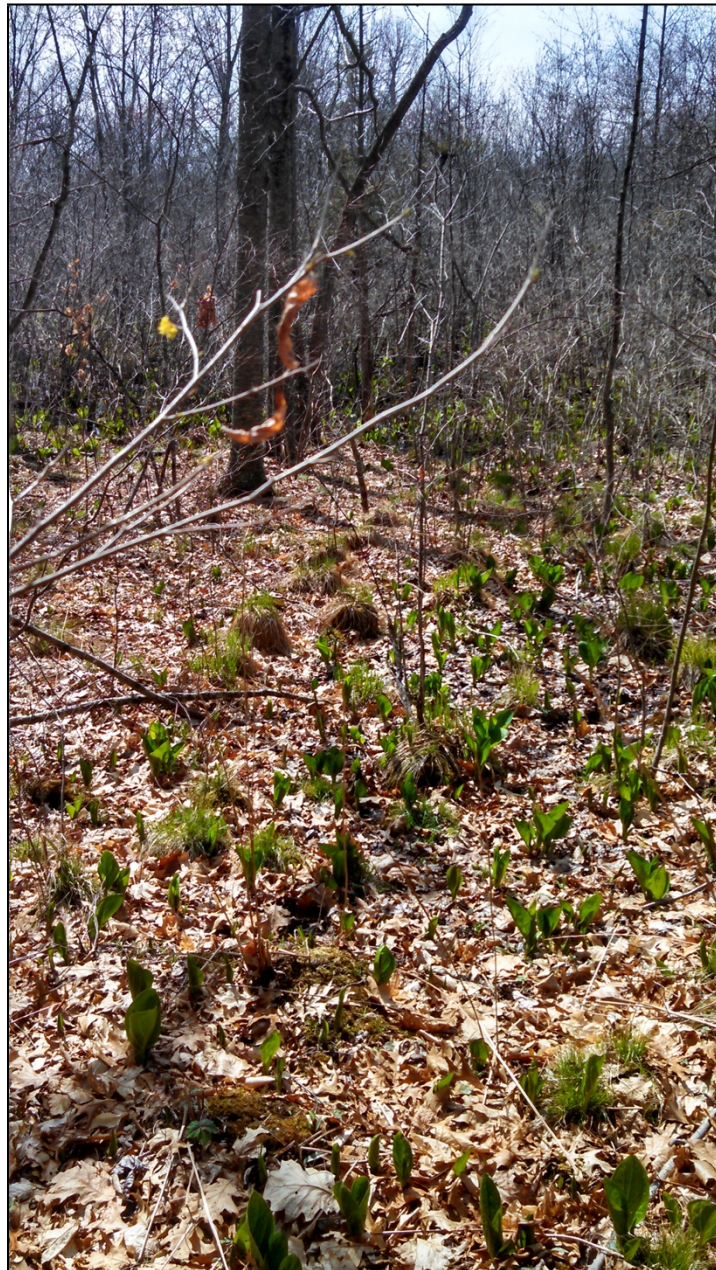
NYSDEC Wetland adjacent to fen.

**Conclusion** - The large NYSDEC wetland (DP-22) delineated on the site is a wetland complex on the southeast and east side of the site that contains shrub swamp, fen, and forested wetland area. Several springs and a spring house are located on the slope at the wetland boundary and soils are mucky with approximately 6 inches of muck associated with rivulets throughout the wetland. The wetland contains groundwater seeps associated with soft mucky soils and upwellings and groundwater discharge areas and is suitable bog turtle habitat. No wetland impacts are proposed.

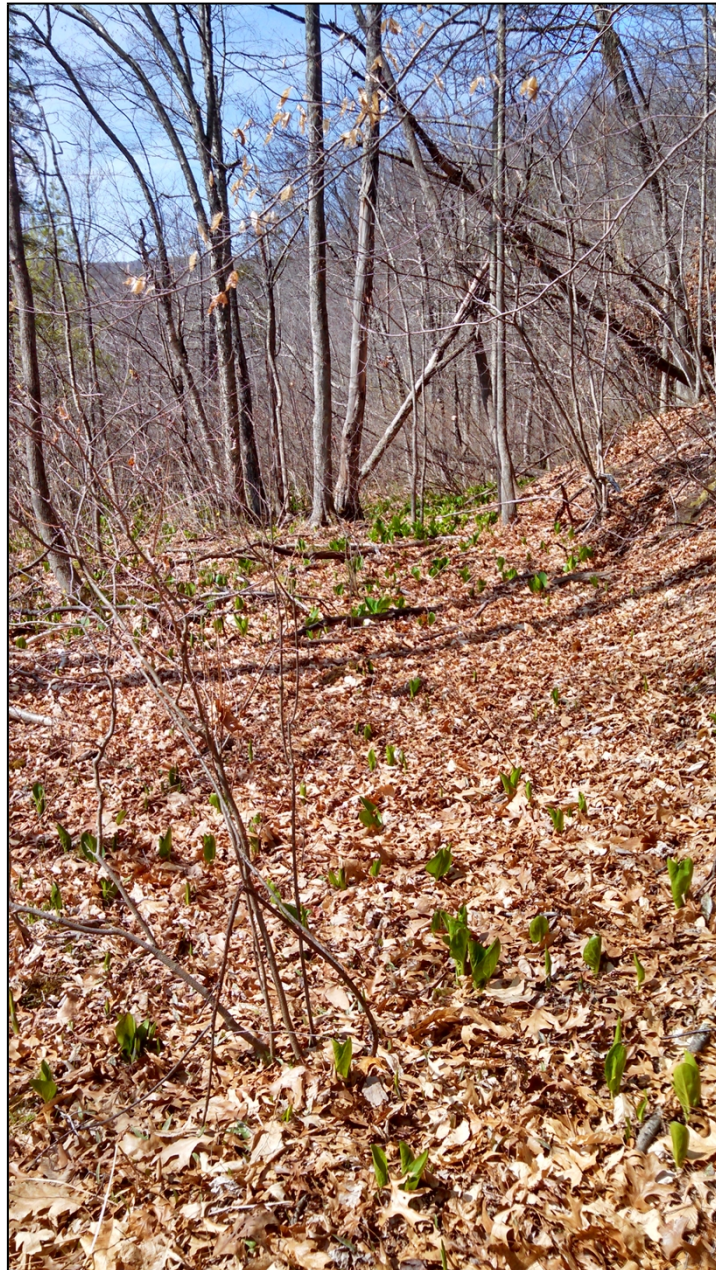
NYSDEC Wetland near spring house.
